2-207 INSPECTION OF AIRCRAFT
STRUCTURES USING MOBILE SOURCES;
A COMPENDIUM OF RADIOGRAPHIC
RESULTS

Training & Servicing/Armament Division
Naval Support Equipment Department
Naval Air Engineering Center
Lakewood, New Jersey 08730

16 APRIL 1979

Final Report for Period 15 May 1977 - 31 December 1978
NAVEDP 2000000-790000-41001-000

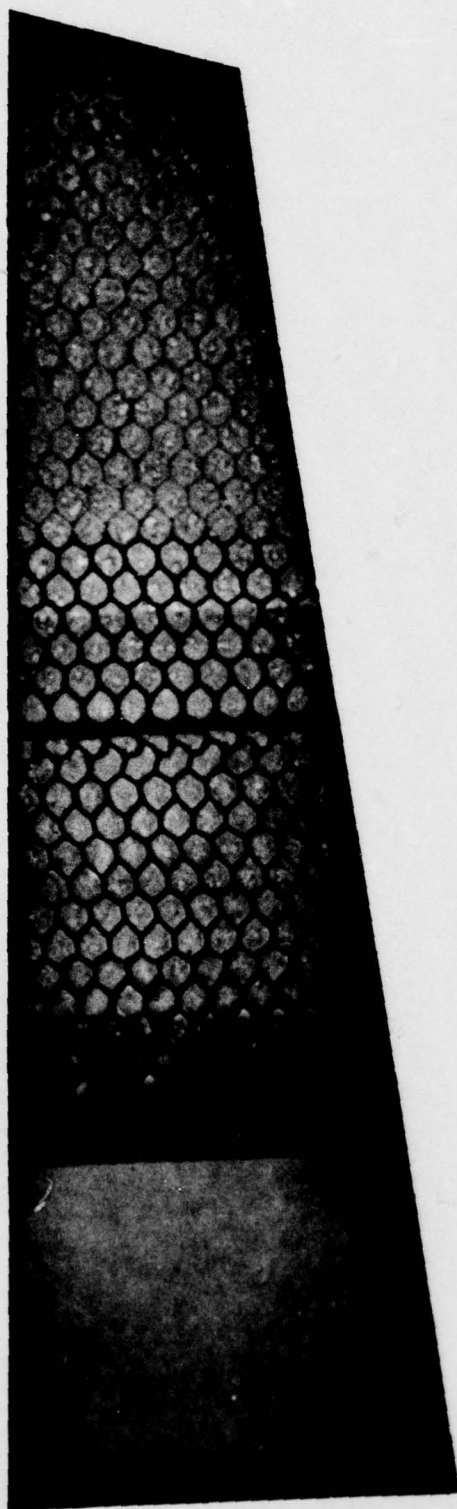
Figure 2 - Neutron Radiograph of Aluminum Honeycomb Aircraft Panel - Side 2

The skin-to-core interface on the opposite side of the panel of Figure 1 is shown here. This side, which was not "in focus" in Figure 1 now appears as a sharp image, illustrating the selectivity of imaging resulting from this type of radiographic system.

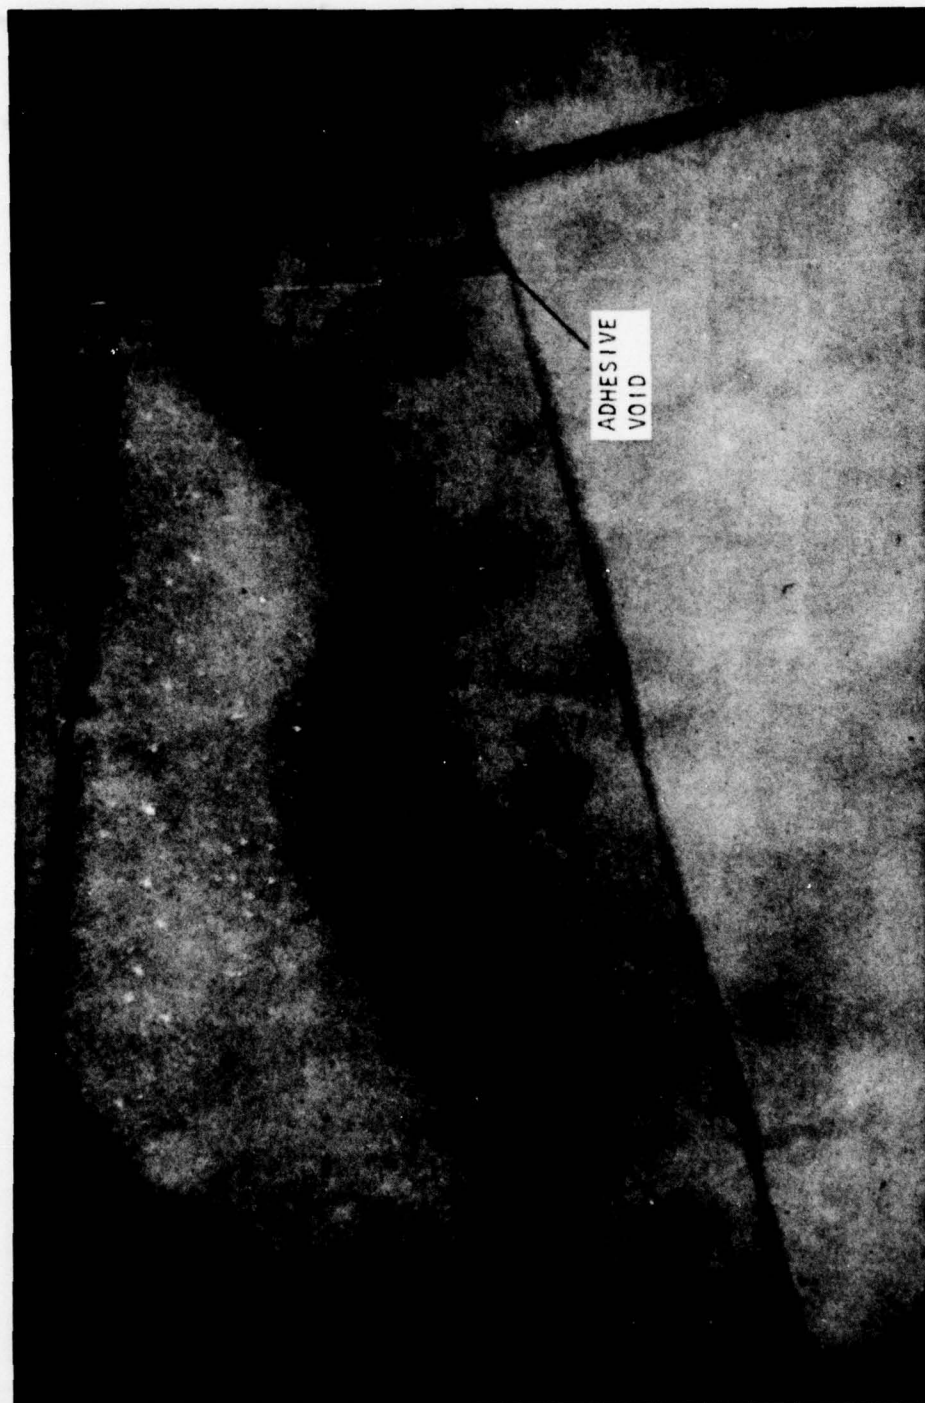
Figure 11 - Fast Film/Converter Neutron Radiograph of Thick Laminated Skin-to-Spar Joint in Aircraft Wing Section

This image shows the results readily attainable for the specimen of the previous radiograph using a faster film/converter combination. It is apparent that the significant bond-line flaws and other features are still imaged, although somewhat less sharply, despite the 16-fold reduction in exposure time. This resolution, however, is adequate for many inspection problems, and in such cases, the increased coverage rate makes inspection with small sources more feasible.

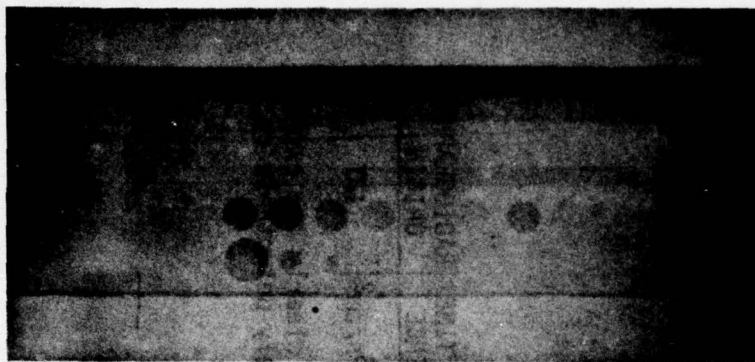
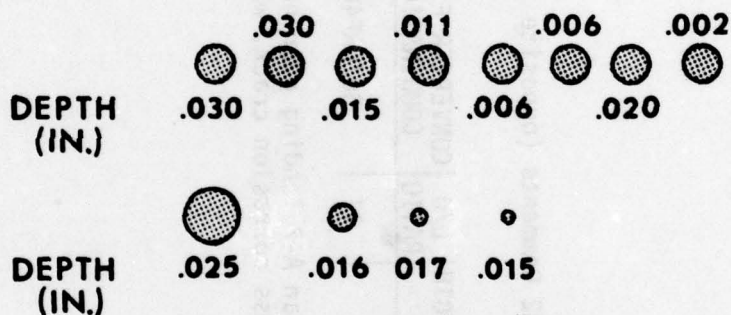
CORROSION SIMULATED BY $\text{Al}(\text{OH})_3$

HOLE PATTERN

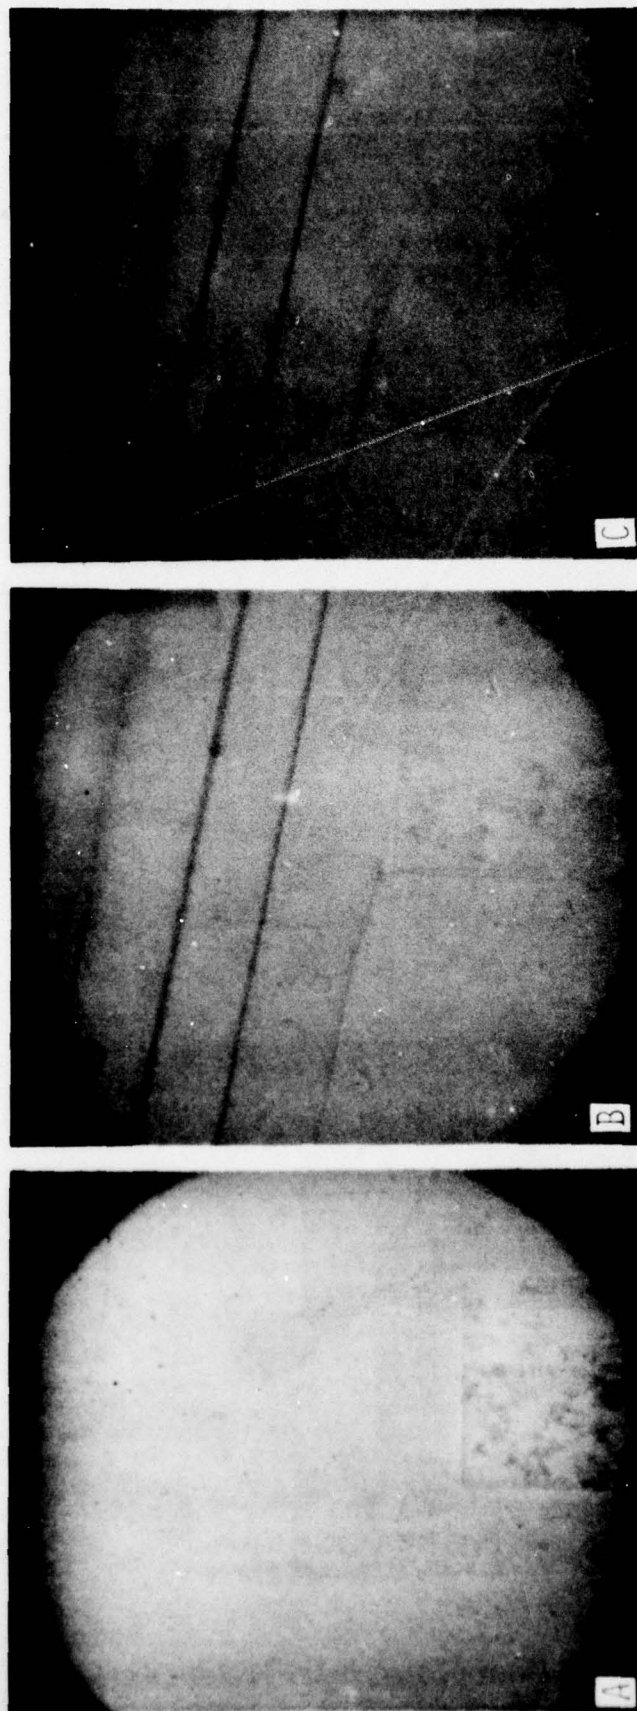
The .0005-inch vapor deposited Gd converter used to radiograph the specimen of Figure 29 was replaced by a Gd₂O₃S screen to obtain these results, for comparison of converter efficiency and resolution (see Table II).
